From Runways to Tunnels: Navigating the Challenges of Tunnelling Underneath Singapore's Changi Airport

ABSTRACT: Thomson-East Coast Line extension (TELe) Contract T316 involves the construction of twin-bored tunnels between Changi Airport's future Terminal 5 (T5) and the existing Changi Airport Station at Terminal 2 (T2). Both bounds of tunnelling works were carried out concurrently using two Earth Pressure Balance Tunnel Boring Machines (EPB TBMs), driven from the launch shaft in the T5 development area towards T2 aircraft stand E5. Hence, critical airport infrastructure had to be undercrossed by the TBMs during tunnelling. The undercrossing of live aircraft movement areas, such as Tango Taxiway, posed additional operational constraints on top of the technical difficulties involved. This paper will discuss how these operational and technical challenges were addressed and assess the effectiveness of implemented measures.

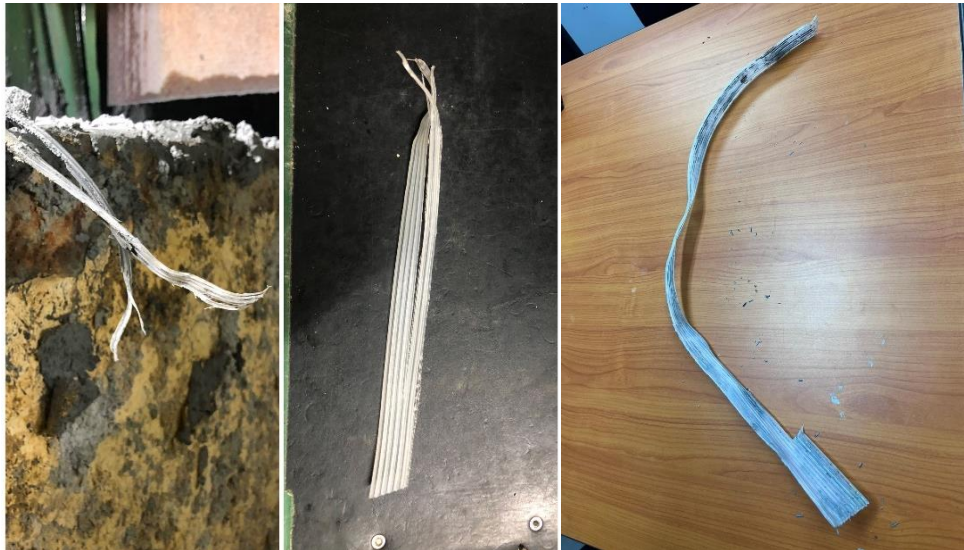
Figure 11: PVDs encountered during tunnelling.

Examples of the PVDs that were encountered and cut during tunnelling are shown in Figure 11. The PVD cutters were effective and enabled the TBMs to excavate the soil without any complications caused by the presence of PVDs.

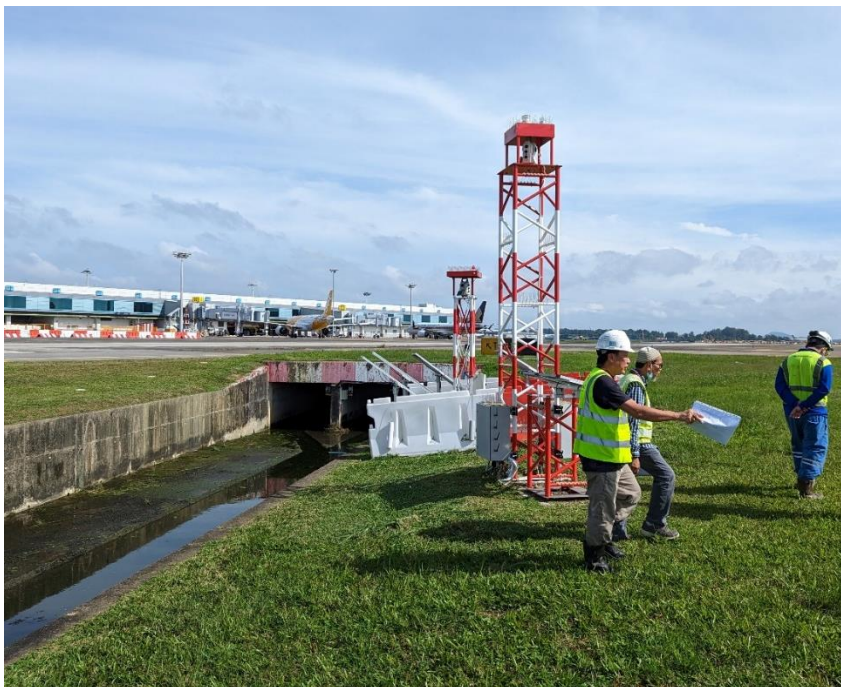
Figure 13: ATS used for reflectorless MOAS grid monitoring.

In addition, as these were operational aircraft manoeuvring areas, monitoring prisms could not be installed on the pavements. Hence, 'reflectorless' monitoring was adopted, whereby an Automatic Total Station (ATS) was used to shoot directly onto the pavements at coordinates determined by the MOAS monitoring grid. An example of the ATS used is shown below.

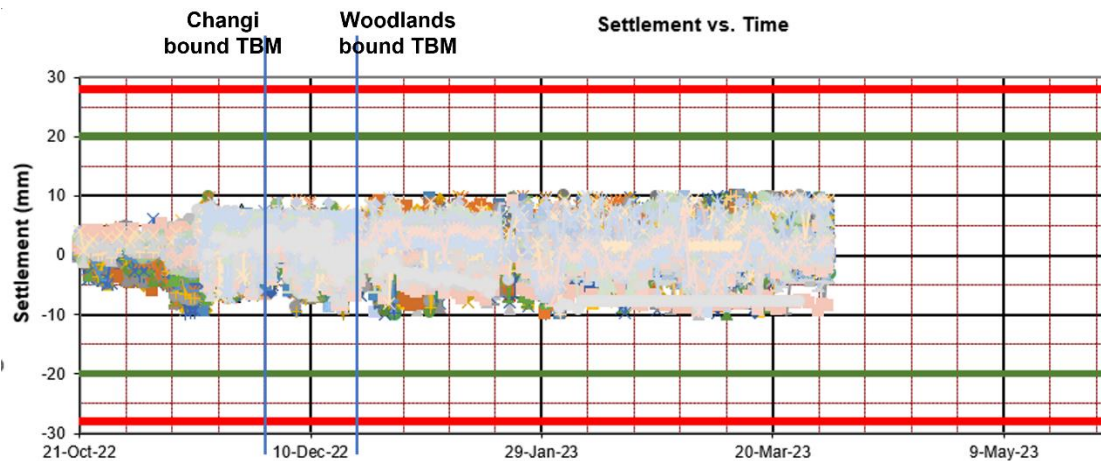
Figure 14. Settlement values at Tango Taxiway.

As demonstrated by the graph in Figure 14, the settlement values at the taxiway remained relatively stable throughout tunnelling. Ground movement was effectively kept within a magnitude of 10mm, well within the alert limits. The post-tunnelling ground movement values remained within the same range.

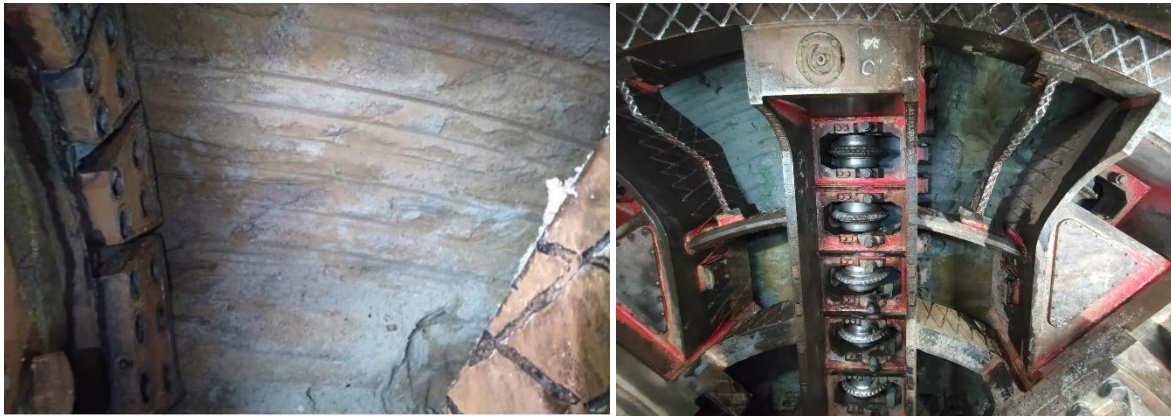
Figure 15. Photos from free-air CHI; (left) Changi Bound and (right) Woodlands Bound.

*8CB and 8WB were located at greenfield locations and were unplanned CHIs which were not selected for free-air CHI during the design stage. The free air CHIs were carried out adhering to the observation approach. During face pressure step-down, it was observed that the excavation face was stable with no signs of erosion or distress, and water inflow and ground movement were all within the allowable range.
