Underpinning and tunnelling undercrossing Keppel Viaduct using specialized cutter tools to cut the piles

Land Transport Authority, Singapore

ABSTRACT: This paper presents the design and construction challenges of underpinning Keppel Viaduct and the successful application of specialized cutter tools on a 6.6m diameter Earth Pressure Balance (EPB) Tunnel Boring Machine (TBM) to cut through its piles in Contract C882 Keppel Station and Tunnels of Circle Line 6 (CCL6). The existing Keppel Viaduct piers FP9 and P51, located near 43 Keppel Road, was undercrossed by the section of CCL6 outer bound tunnel, that runs from Keppel Station to Cantonment Station. Two bored piles of Pier FP9 and six micropiles of Pier P51 were within the face of the proposed outer bound bored tunnel alignment. Underpinning works to the structures with micropiles were proposed and following load transfer, the existing affected piles were cut to disconnect them from the pier and subsequently bored through during the tunnelling stage.

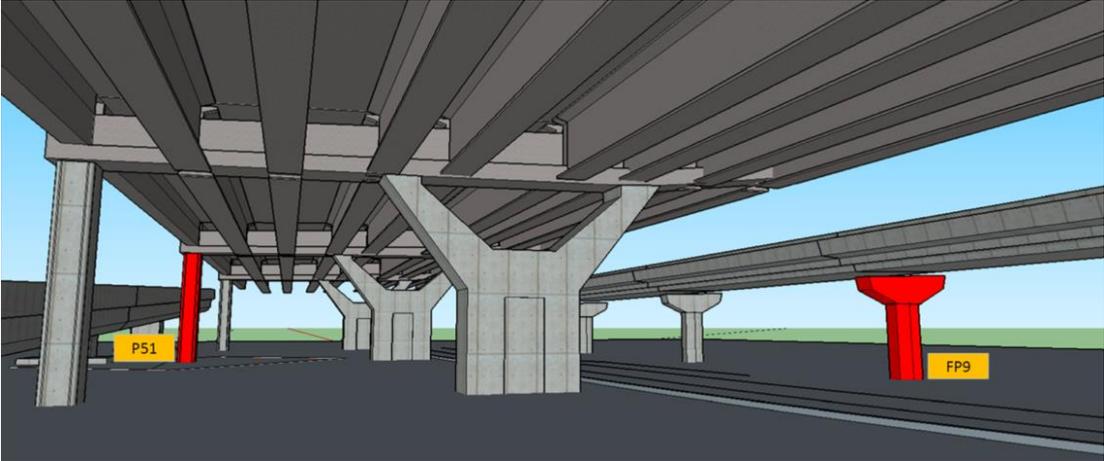
Figure 3. 3D rendering of the two affected piers

Figure 2 shows a plan view of the tunnel drives from Keppel Station to Cantonment Station and the proposed undercrossing locations at the outer bound tunnel. Pier FP9 is a solitary pier supporting the Keppel Viaduct ramp, while pier P51 supports an extension of the Keppel Viaduct. Figure 3 shows a 3D rendering of the abovementioned piers.

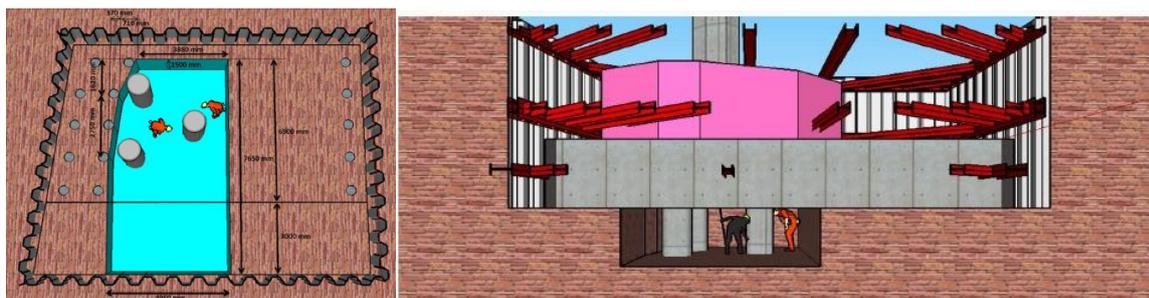
Figure 12. Schematic demonstrating the pile cutting procedure with plan (left) and section (right) views

After the pile jacking works had been completed, the original piles should no longer be supporting load from the pier. These piles will have to be disconnected from the pier to facilitate the process of tunnelling through them, as the TBM would likely cause movement to the pier if they remain connected. A wire saw was used to cut a 200mm section from the piles to fully disconnect them from the pier. This was carried out by excavating beneath the transfer beam as shown in Figure 12 and cutting the piles one at a time. The excavated area was subsequently backfilled once this process was completed. Figure 13 shows the actual piles during and after pile cutting.

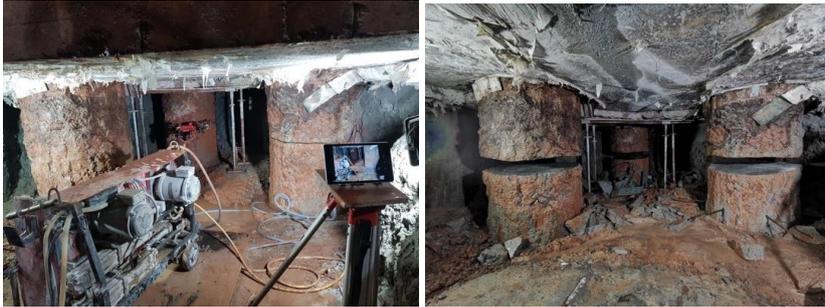
Figure 13. Images of the piles during (left) and after (right) the pile cutting

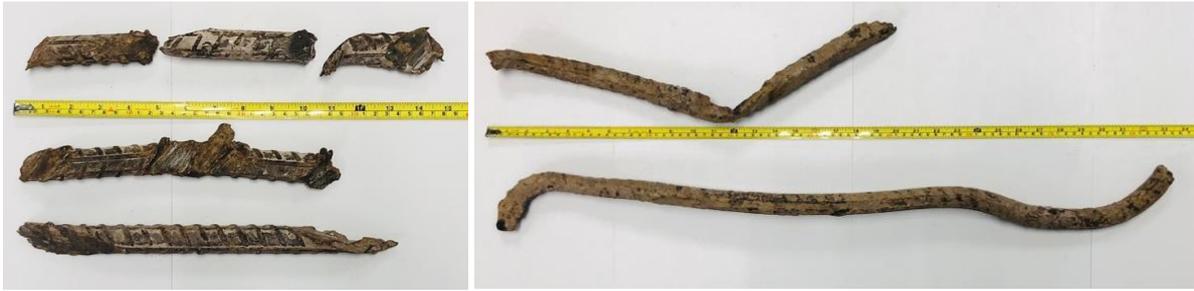
Figure 20. Photos of the rebars retrieved from the excavation chamber after cutting through the piles

Large number of rebar segments were accumulated at the bottom of the excavation chamber and they were removed manually during CHI to prevent the possibility of it subsequently jamming the screw conveyor. This accumulation of rebars segments in the excavation chamber was expected, as during pile cutting, the screw conveyor operated at a very low speed to maintain the face pressure. Analyzing the rebar segments' cutting marks and the average length per segment concludes that the specialized cutter tools were effective in cutting the rebars into small segments as intended. On average, the rebar segments were less than 300mm in length. The rebars shown in Figure 20 demonstrated shearing patterns on its edges, indicating that the specialized cutter tools were effective in cutting and performed as intended. The longer rebars found were possibly caused by the cutting of the rebar ends before it could be further cut into smaller segments.

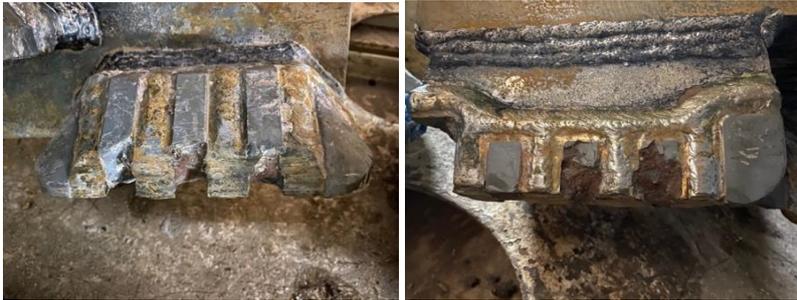
Figure 21. Images of the worn off cutter tools after cutting through the piles

Upon removing the specialized cutter tools, it was observed that some of the tungsten carbide inserts were worn as shown in Figure 21.

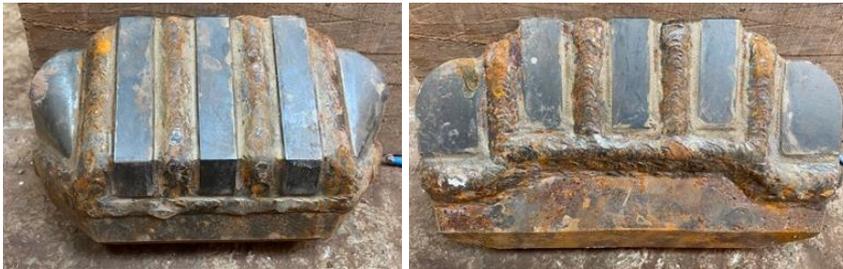
Figure 22. Replacement specialized cutting bits

Replacement cutting bits shown in Figure 22, were ordered in advance as the wear in the cutting bits was anticipated. The specialized cutter tools were refurbished by replacing the worn-out cutting bits with new cutting bits by a specialist welder. This is to ensure that the subsequent pile cutting operation at pier P51 would remain as effective. The refurbishment was done after cutting through the piles of pier FP9, while was tunnelling towards the piles of pier P51.
