APPLICATION OF GROUND FREEZING FOR MINED TUNNEL IN T226 MARINA BAY STATION

Sim Zhan Rui

Land Transport Authority, Singapore, Email: Sim.Zhan.Rui@lta.gov.sg

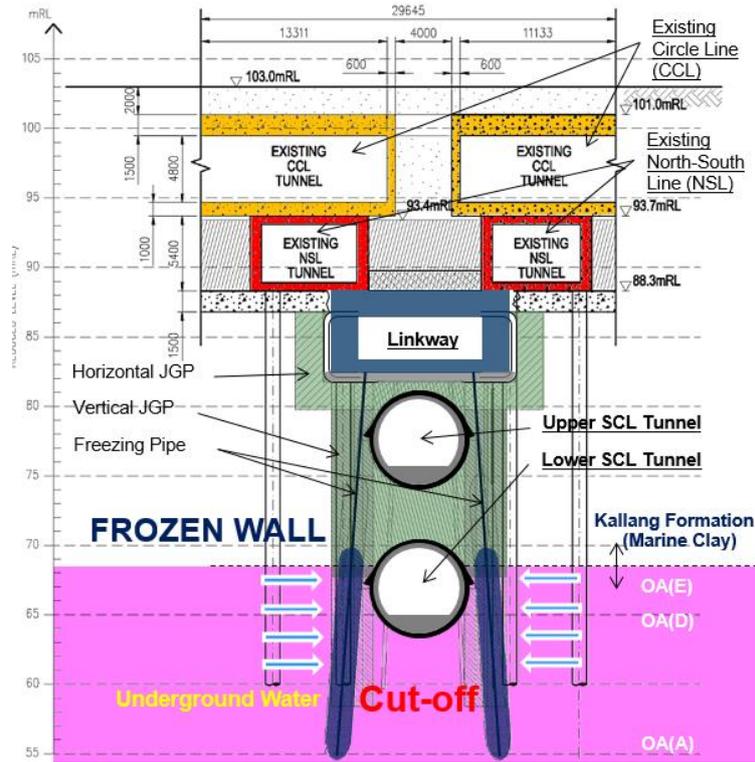
Figure 1. Overview of T226 Ground Improvement

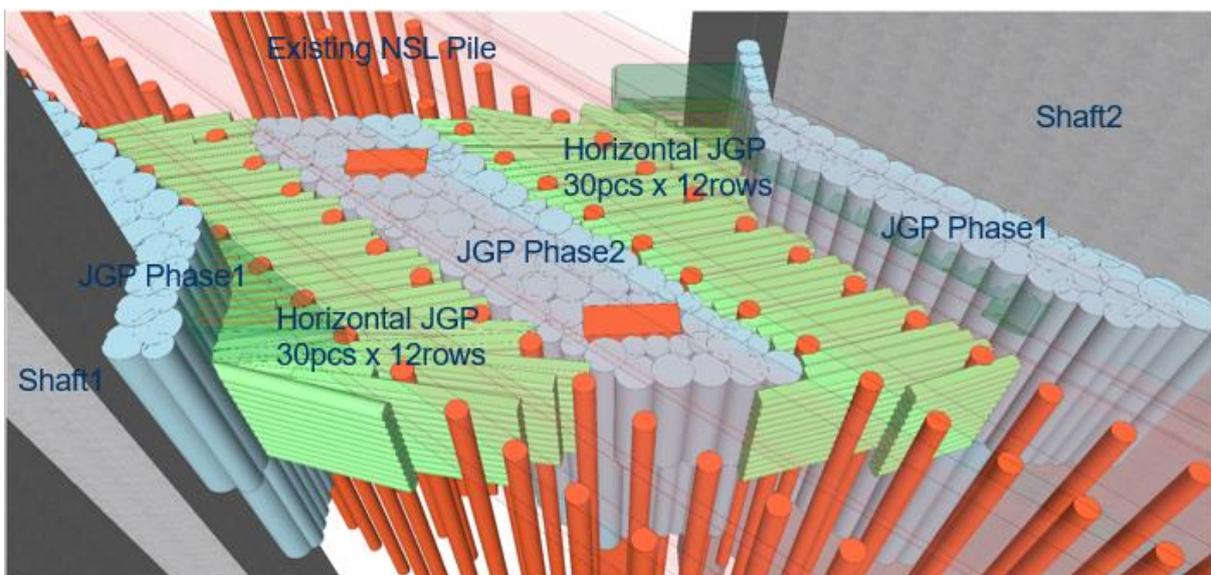
Before Ground Freezing works could commence, tedious stages of ground improvement works had to be carried out. The spaghetti of Live MRT tunnels were in the way of a straightforward approach to ground treatment. In order to ensure an effective all-round treatment, 4 phases of vertical JGP and 2 phases of horizontal JGP were carried out. This would ensure that the new pedestrian linkway, upper tunnel and crown of lower tunnel could be constructed in well treated ground.

Figure 2. Vertical and Horizontal JGP for Adit Mining

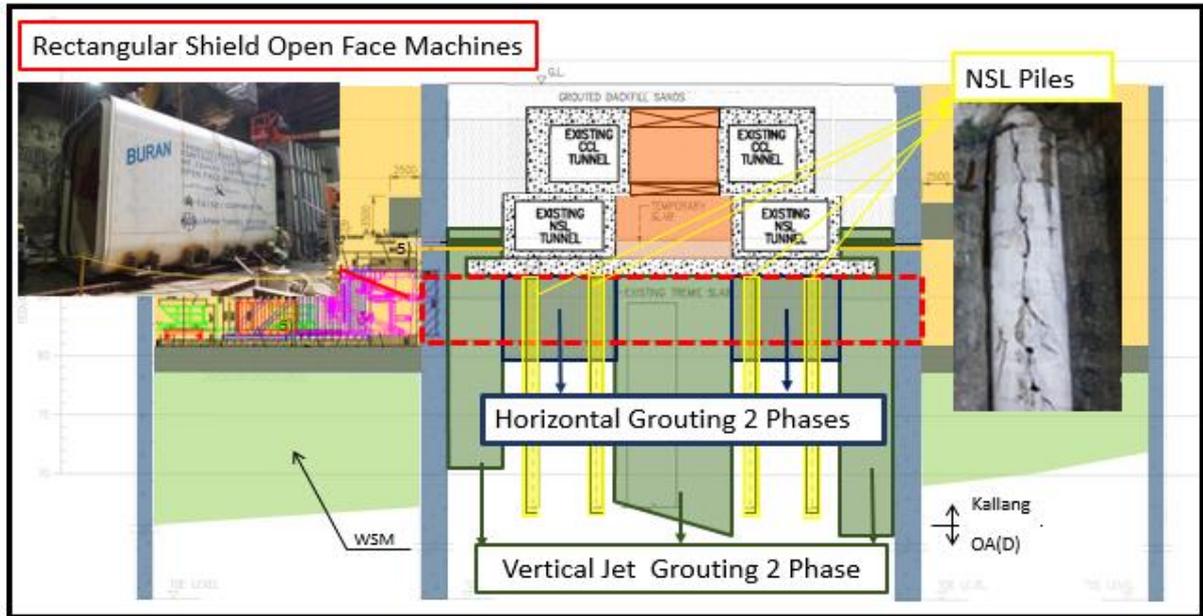
The pedestrian linkway not only served its purpose of underpinning the NSL live MRT tunnels, but it also provided a stronghold, for the safe execution of Ground Freezing works. The adits were constructed via the use of Rectangular Shield Open face Tunnelling Machines. The use of horizontal JGP ensured that the tunnelling works were carried out in well treated ground. Subsequently, various stages of mined excavations allowed for the transfer slab and temporary base slab of the pedestrian linkway to be constructed, to pave the way for Ground Freezing works.

Figure 3. Underpinning of North-South Line

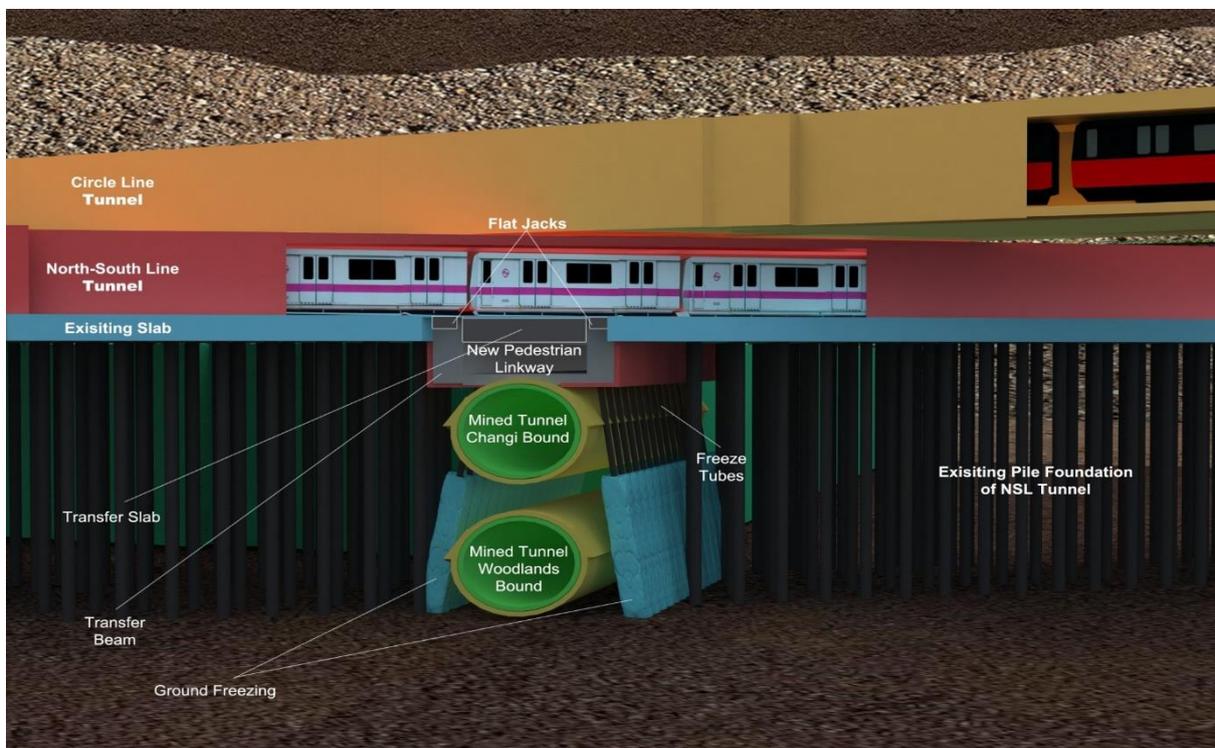
Figure 4. Overview of T226 Project

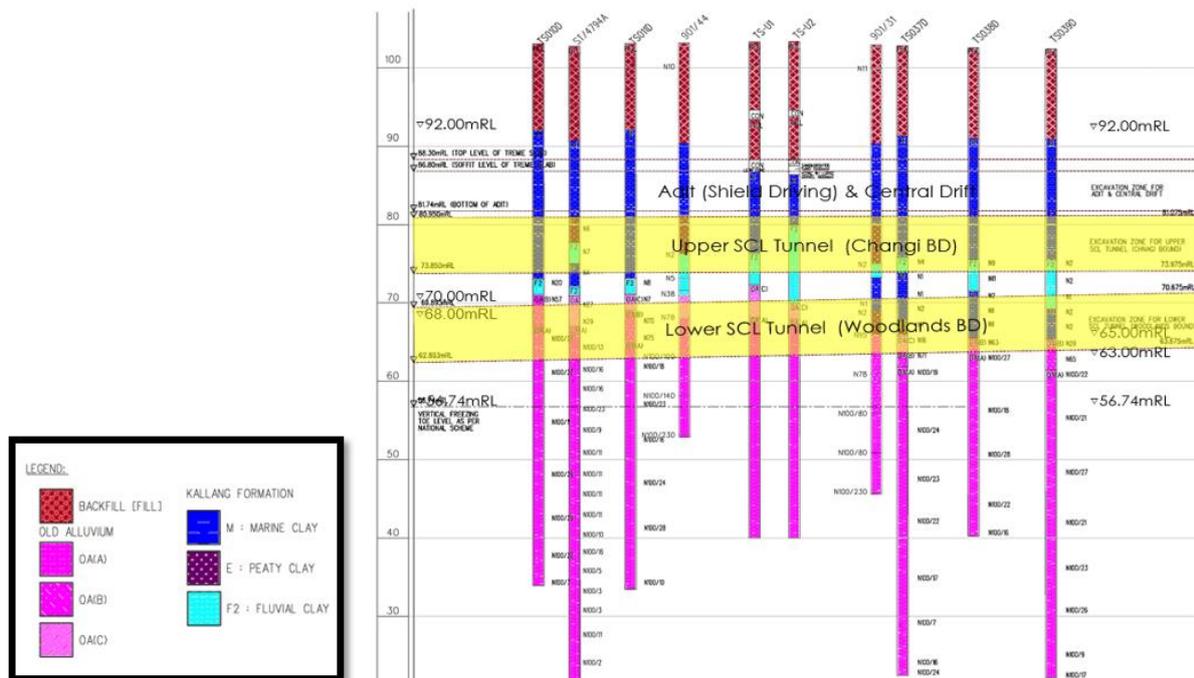
The geology which upper bound tunnel had to be constructed in consists mainly of highly permeable Sand and soft Marine Clay while the lower bound tunnel had a mixed geological condition of a harder, sandier and permeable Old Alluvium layer and Marine Clay.

Figure 5. Geological Profile of T226

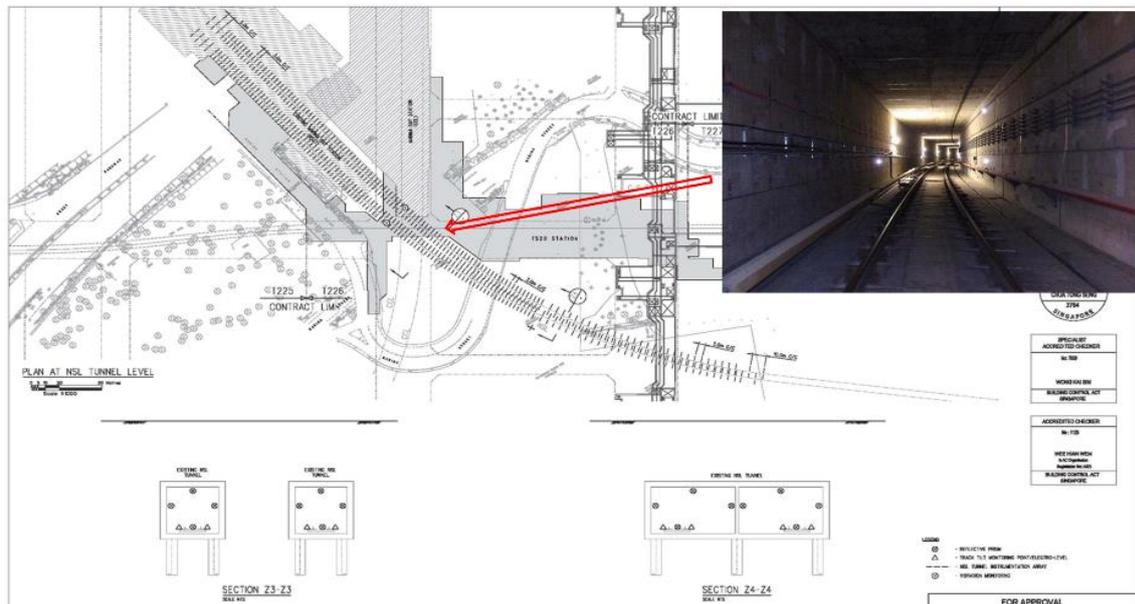
Our main concern will be causing any damage to the existing operating tunnels, therefore intensive Instrumentation monitoring had to be carried out to ensure safe operation for our stakeholder. Live primis were installed in both NSL and Circle Line, where it provides a live time monitoring. This will reflect any potential movements caused by our construction activities that takes place under the tunnels. The readings were monitoring closely and discussed in daily meeting to ensure all works were carried out safely and a strong reason why the stakeholder can set their mind at ease with our works.

Figure 7. Real-time Monitoring for Existing NSL Tunnel

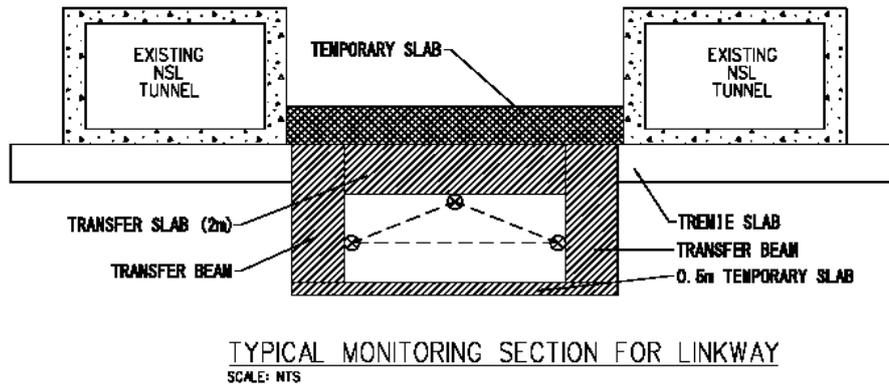
Besides the live tunnels, structures such as the linkway were also monitored with RX and LU.

Figure 8. Convergence Monitoring for Linkway

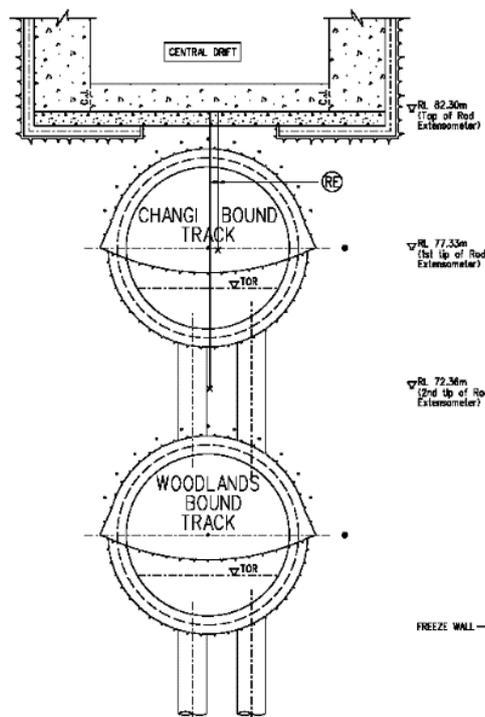
Figure 9. Rod Extensometer from Linkway

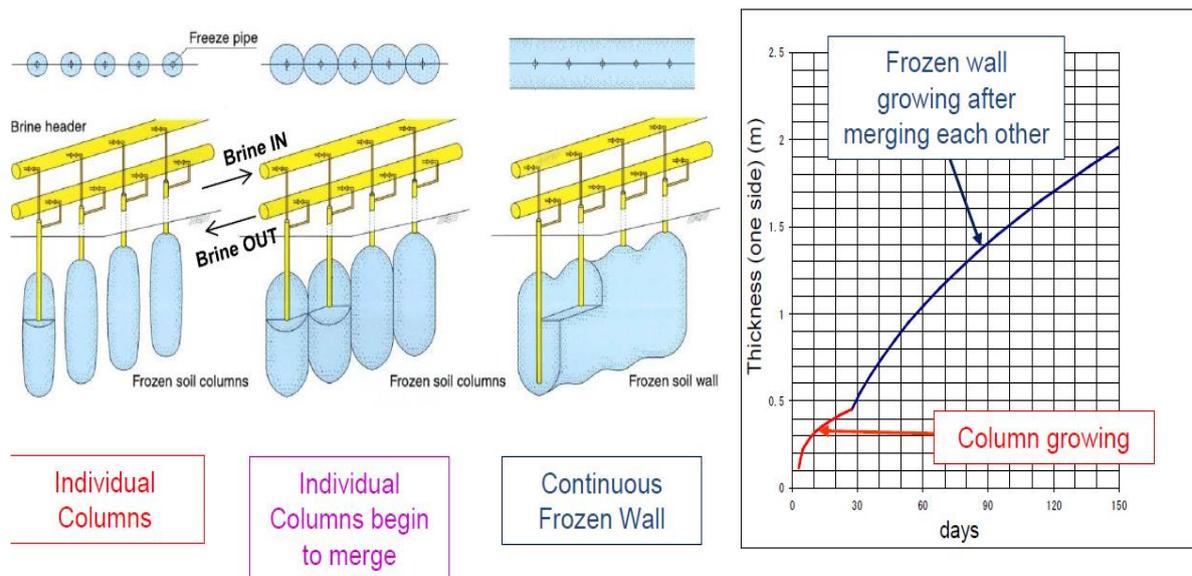
Ground Freezing was used in T226 to form up ice walls at both sides of tunnel excavation area in order to achieve water cut-off, without which, dangerous water ingress could happen at the weak ground and hard OA interfaces, causing any impending danger to existing structures or MRT tunnels. The design of the freezing system consists of Freezing pipes installed into the ground at a depth of around 28 meters and circulation of subfreezing temperature brine into the freezing pipes. When the moisture of soil is being to expose to the subfreezing temperature, it changes its state from liquid to solid. Frozen soil columns will then be formed around individual freezing pipes and as the ice columns grow over time, they will merge together to form a continuous frozen wall.

Figure 10. Ground Freezing Concept

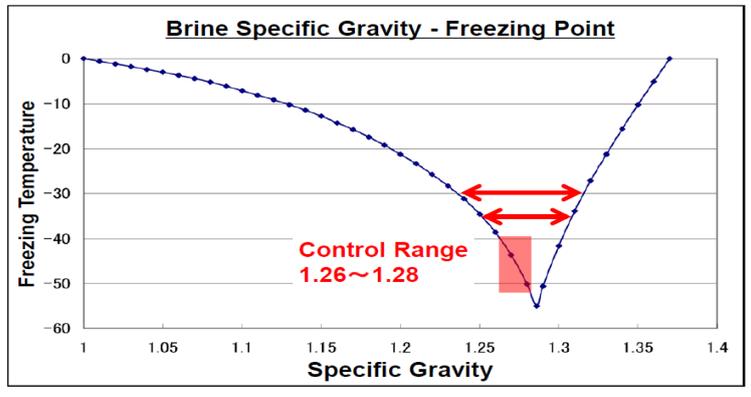
Bine is a mixture of Calcium chloride with water. A 30% concentration can achieve a density of 1.26-1.28, allowing the brine temperature to reach -30 degrees C.

Brine : Calcium Chloride + Water **Concentration :30% (Seawater :3%)**
Specific Gravity: 1.26~1.28
Brine temperature: -30 degrees C

Figure 11. Brine Freezing Point

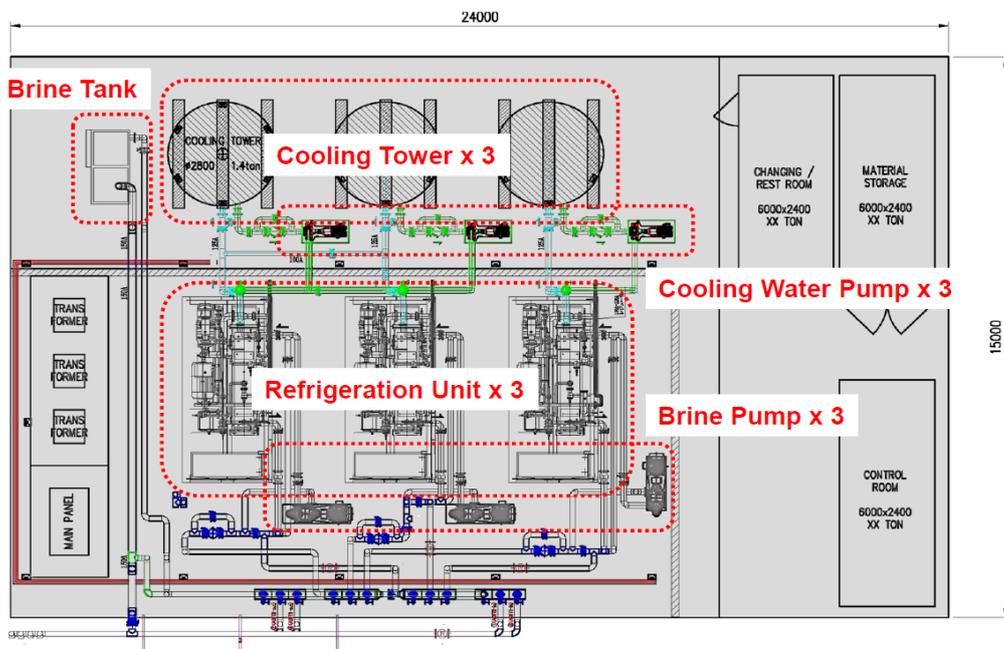
Ground freezing system in T226 consist of a freezing plant on the surface and pipelines runs from the plant and into the forming a close loop system. The layout of the freezing plant is as shown in Figure 12.

Figure 12. Freezing Plant Set up

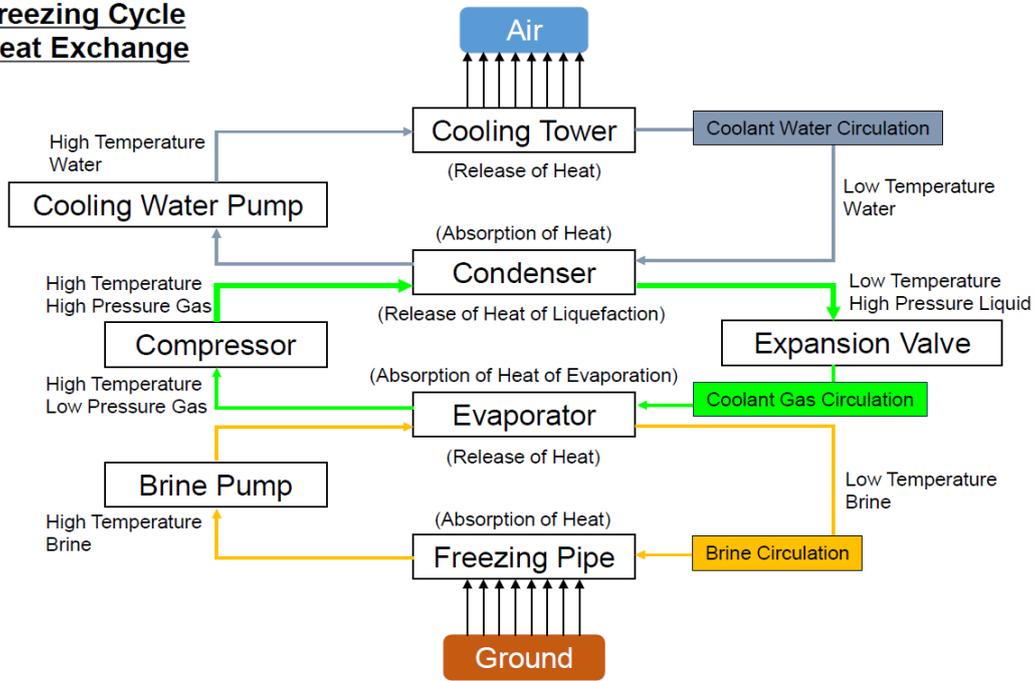
Brine was being chilled to -30-degree C by brine cooler and pumped to central drift header pipes where it circulated into the individual freezing pipes. While being circulated, heat from the ground was transferred to the brine before they returned to the brine cooler. Figure 13 below shows the heat transfer concept in summary.

Figure 13. Heat Transfer Concept

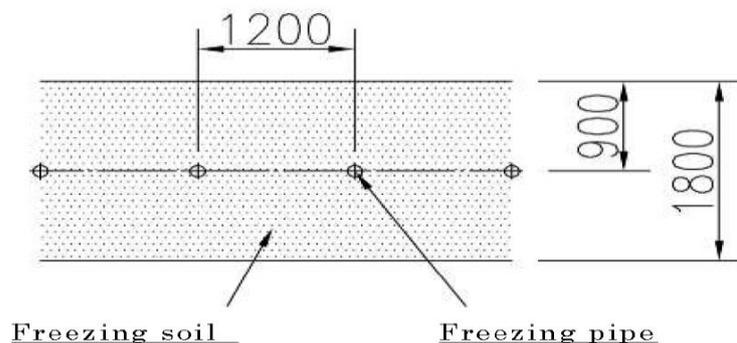
The freezing pipes were designed to be installed at 1.2 meters apart from each other and the required thickness to ensure water tightness was 0.9 metres at single side from the freezing pipe.

Figure 14. Freezing wall Thickness

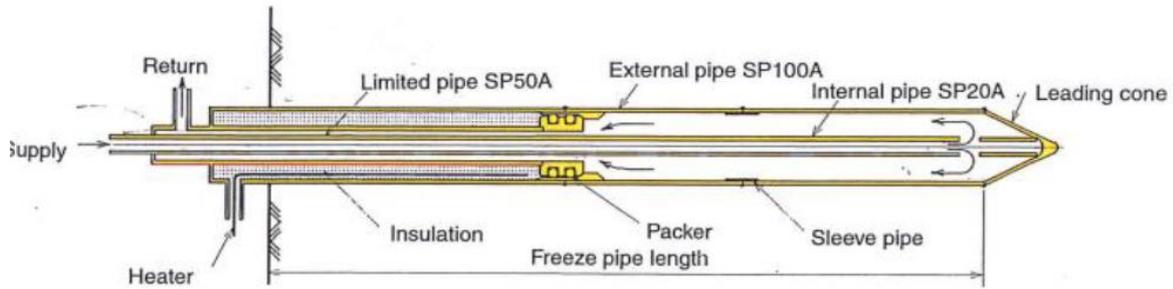
· **Limited freeze pipe (Used for partial vertical freezing)**

Figure 15. Cross Section of Freezing Pipe

Freezing pipes consist of 3 components, outer pipes, limitation pipes and inner pipes. Freezing pipes were installed from the central drift by first drilling to the require depth and then installing the pipes in sections of 2.75 meters where connections of the freezing pipes were fully welded together.

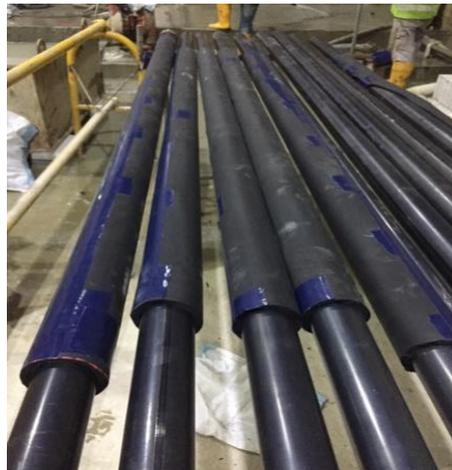
Limitation pipes were then installed within the outer pipes with the purpose of preventing brine circulation along the full length of freezing pipes to keep the frozen area at the minimum required level to prevent any unnecessary movements through the frost heave effect.

Figure 16. Limitation Pipes

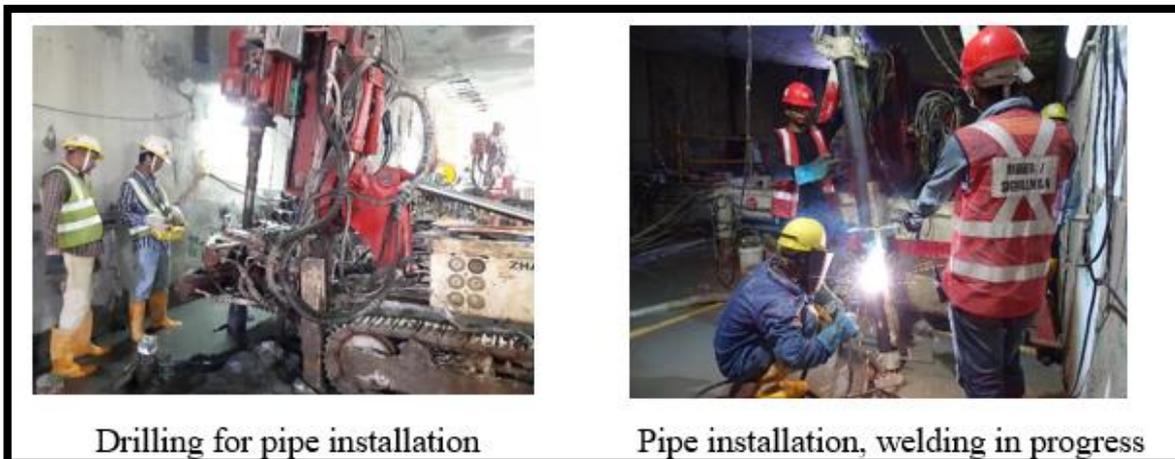
Drilling for pipe installation

Pipe installation, welding in progress

Figure 17. Freezing Pipes Installation

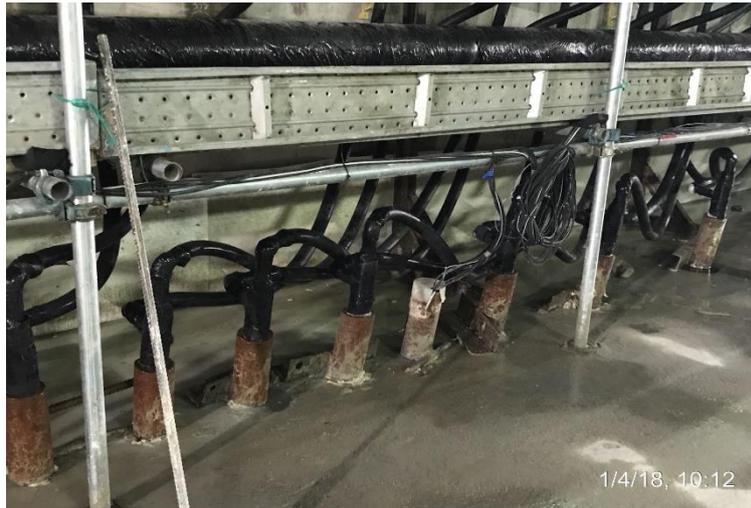
Figure 18. Freezing Pipes

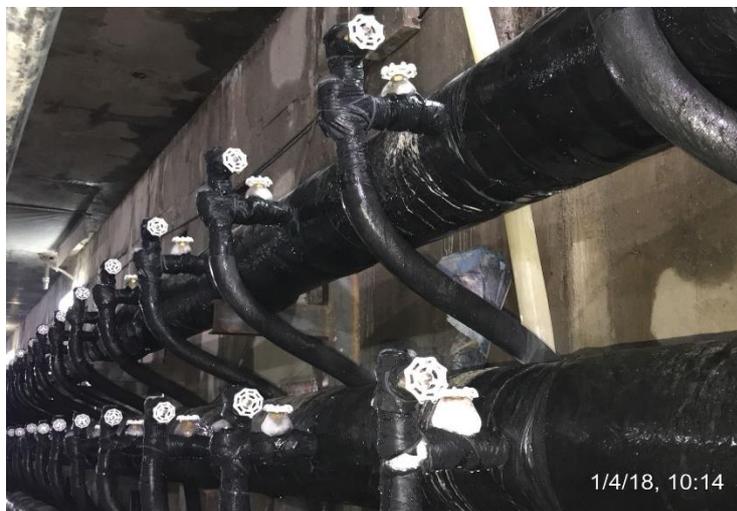
Figure 19. Values of individual Freezing pipes

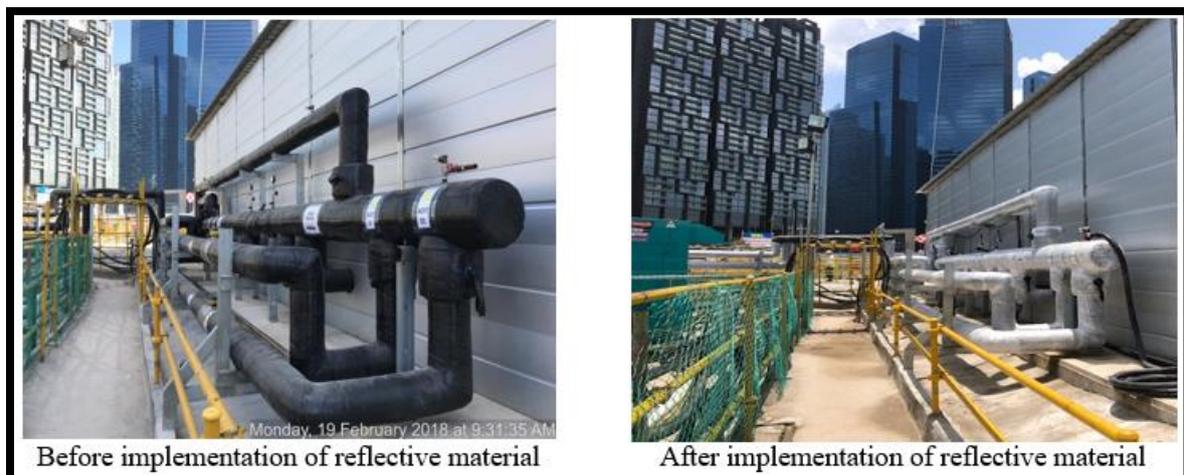
Monday, 19 February 2018 at 9:31:35 AM
Before implementation of reflective material

After implementation of reflective material

Figure 22. Reflection material implemented to reduce heat absorbing

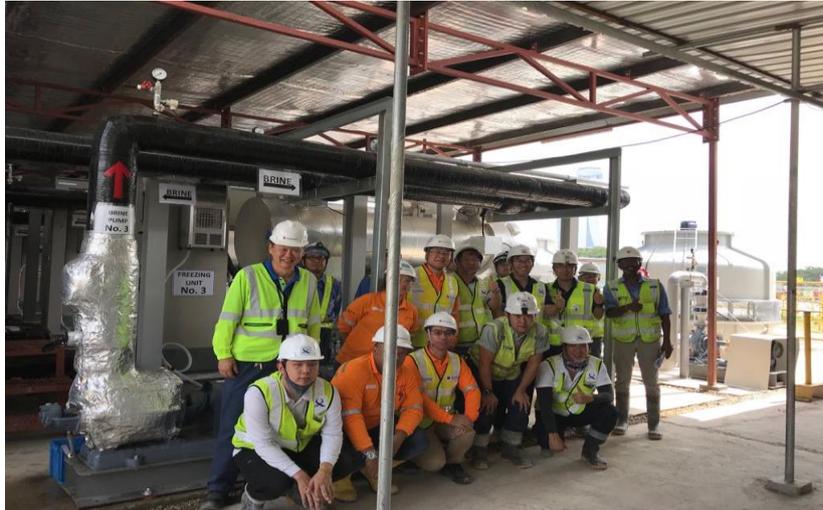
Figure 23. Completion of Freezing Plant Inspection

For Ground Freezing works, the mechanical design and implementation were fully undertaken by Seiken. To close up any safety lapse in this aspect, we incorporated and involved internally our Electrical and Mechanical Project and Design specialists to review the implementation of the plant set up. All the comments were tabulated and addressed, strengthening our supervisory regime not just on the civil engineering aspect of the work, assuring good functionality, reliability of the Ground Freezing works. Freezing Plant inspection and acceptance test were carried out as it was critical to ensure the formation of ice wall and maintaining it during the lower bound tunnel excavation. A plant maintenance plan was requested and carried out daily, witness by our Qualified Personal.

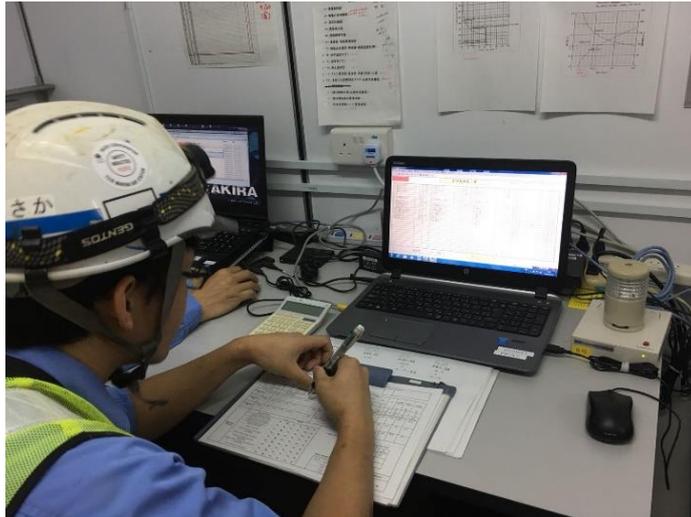
Figure 25. Monitoring of Ground Freezing Plant Parameters

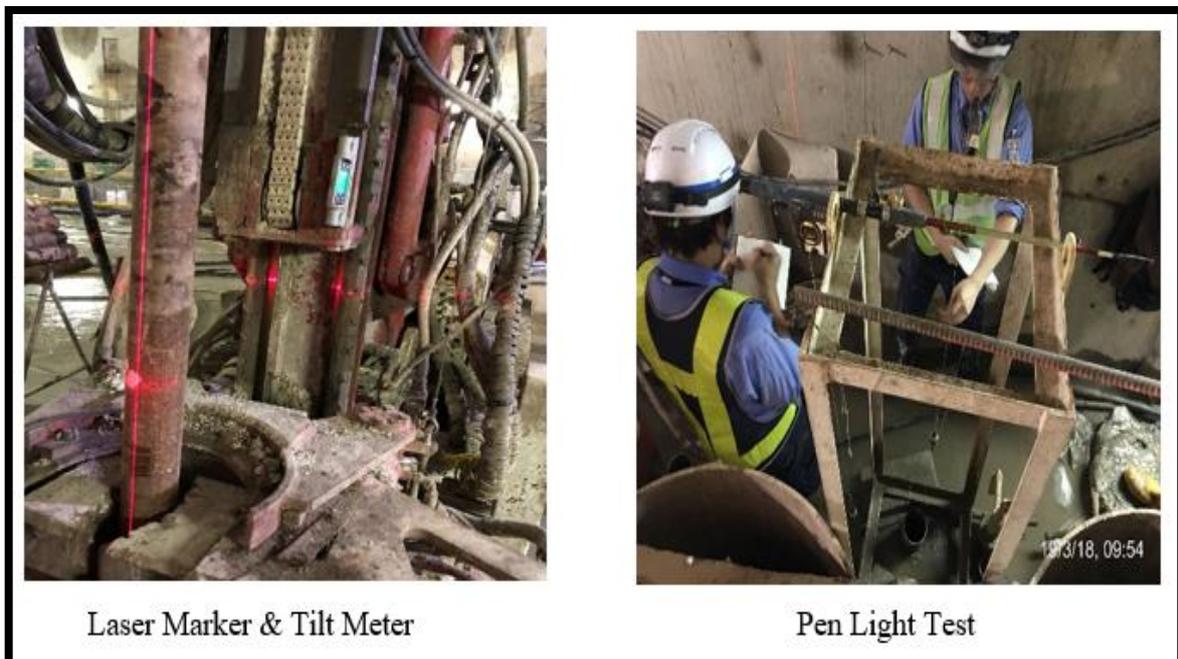
To prevent misalignment, laser marker and tilt meter were used to ensure that pipes were installed at the correct alignment and angle. Pen light test to verify the pipe alignment and angle. At our direction, all these works had to be witnessed by our Qualified Site Supervisor.

Figure 26. Ensuring alignment of Freezing pipes

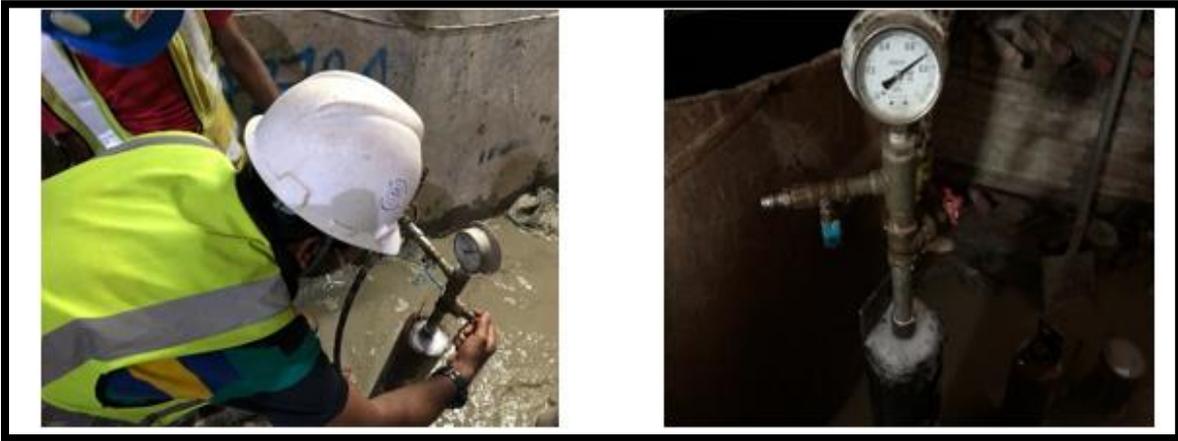
All prefabricated outer & inner freezing pipes were delivered to site with standard length at 2.75m. During installation, every welded joints were to be tested by compressed air to ensure no leakage.

Figure 27. Air Leak Test

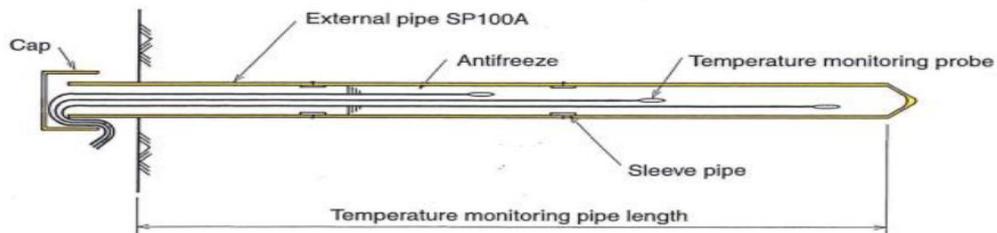
The formation of ice wall was monitored by Temperature monitoring pipes. During the freezing operation, temperature data obtained by detector were transmitted by the Data Logger to the Control Room computer software. Where it was able to produce the different diagrams of the ground temperature in terms of time, position and distance. 20 temperature monitoring pipes were installed along both sides of the freezing pipes at an interval of 4 metres and within each temperature monitoring pipes, 4 thermo-couplers were located at different levels.

Temperature monitoring pipe (Used for vertical temperature monitoring)

Figure 28. Temperature Monitoring Pipe

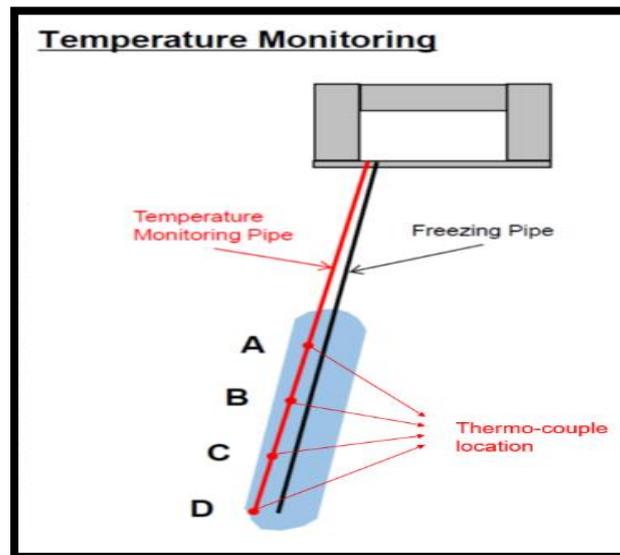
Figure 29. Thermo-Couple Locations along temperature monitoring pipe

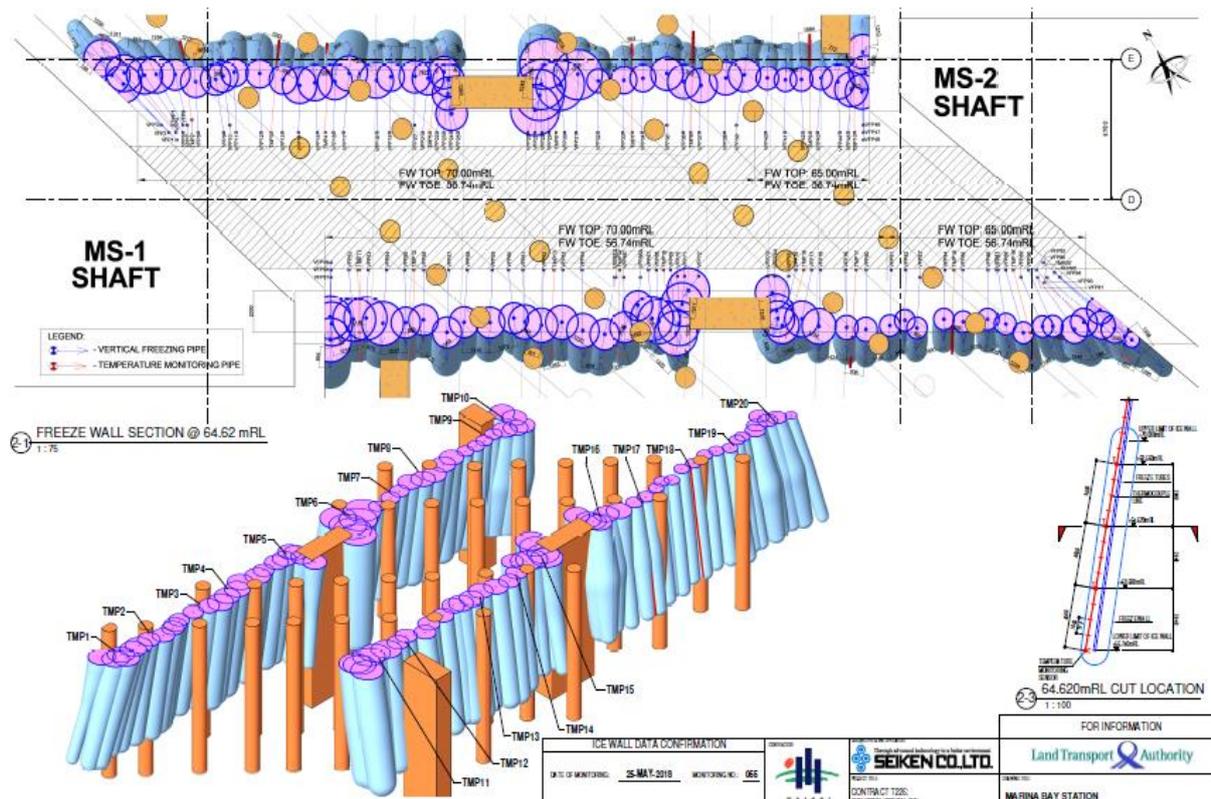
As we require the temperature monitoring to be readily interpreted and understood, the 3D BIM model was developed daily, translating numerical temperatures into figures which enabled us to have a clearer picture on how the temperature reflects in terms of thickness. This was crucial as we were able to monitor based on the ice thickness of individual pipes on a daily basis and check for any discontinuity in the walls before excavation works could proceed. Mitigation actions can be taken where we feel the ice is not growing as planned.

Figure 31. BIM Model of Ice Thickness for Daily Monitoring

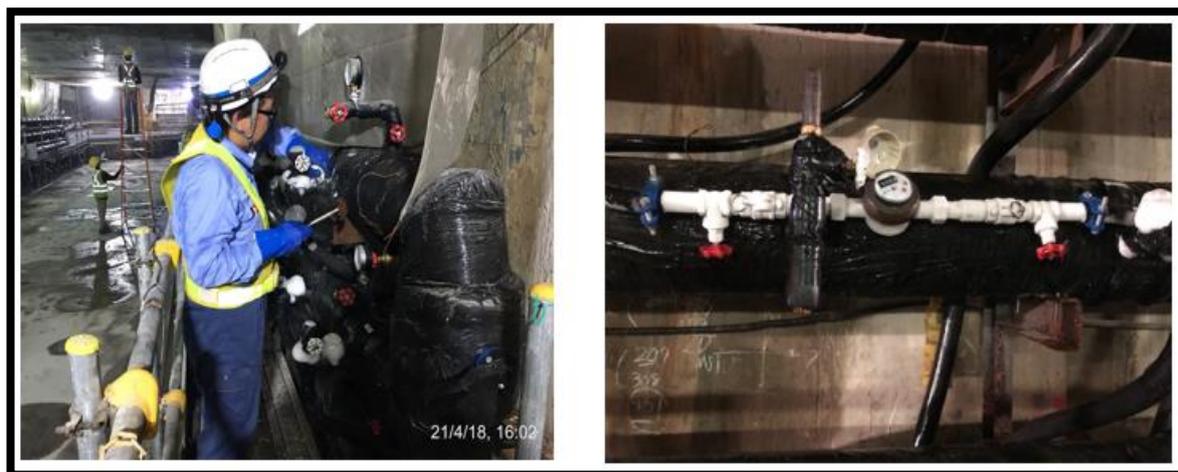
For heat transfer to take place at a constant rate, flow rate of individual pipes was monitored daily and with the temperature of the supply and return brine of individual pipes, it enables the performance of each freezing pipe to be monitored.

Figure 33. Monitoring of Freezing pipe

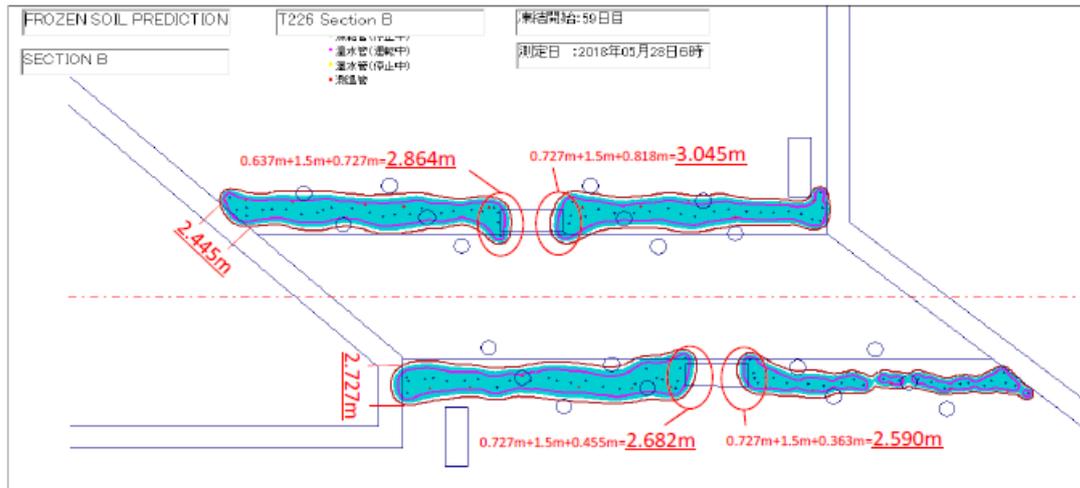
Not only taking reference from the temperature monitoring pipes, additional thermo-couplers were installed along the D-walls to ensure that the ice encroaches into the D-walls. This was to prevent water slippages between the excavated area and D-wall. As shown in figure 34.

Figure 34. Confirmation diagram of Ice Wall Formation

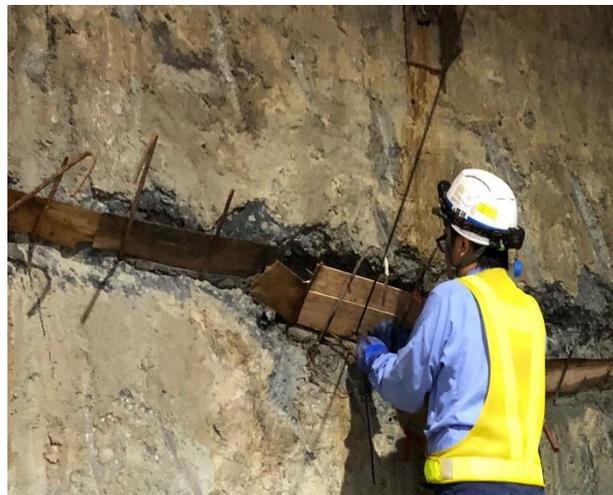
Figure 35. Installation of Thermo-Couple on D-wall

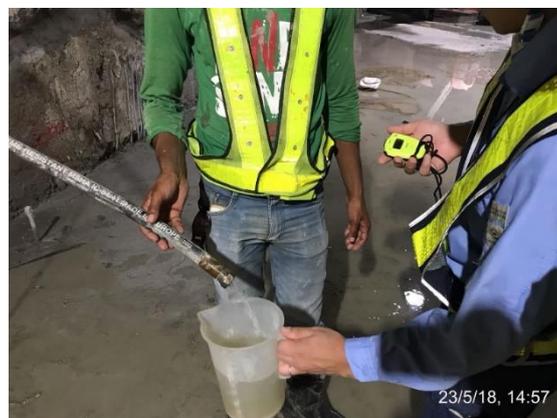
Besides monitoring of temperature, water ingress from within the excavated area also raise our confidence in the ice wall formation as amount of water ingress and its temperature can reflect if the ice walls were fully formed. Actual temperature records of the water ingress were at around 30°C which was about the same as ground temperature taken initially shows that the water ingress comes from trapped water within the confinement of the D-wall and frozen wall.

Figure 36. Water Ingress Check

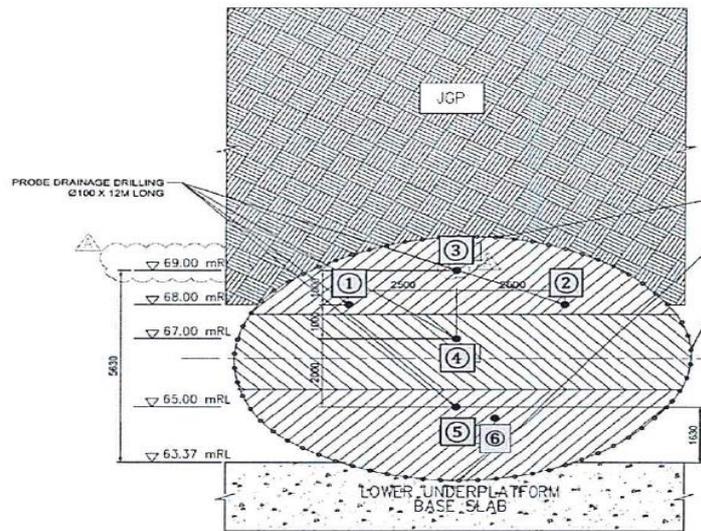
Water ingress recorded shows minimal amount of water ingress from the top heading with treated JGP layer and Old Alluvium layer.

Figure 37. Probe Drilling Location

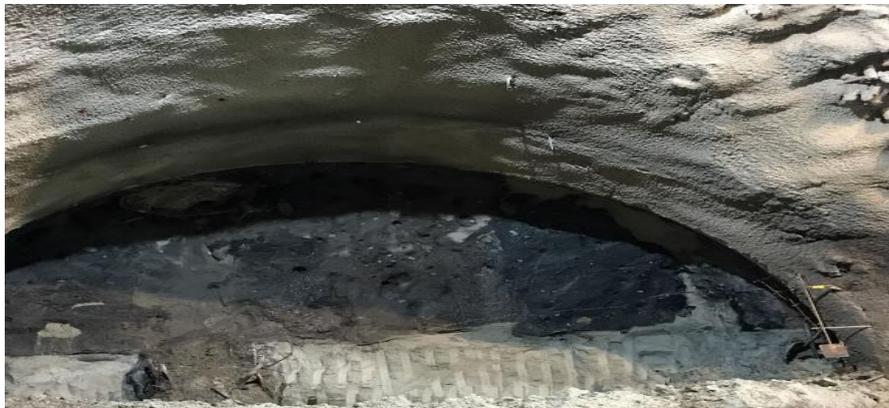
After the breakout, top heading had a well-treated JGP block and for the Old Alluvium layer which was govern by the ice walls had a dry condition with minimum water ingress. The lower bound tunnel completed excavation with no soil collapse and any extensive water ingress.

Figure 38. JGP Condition

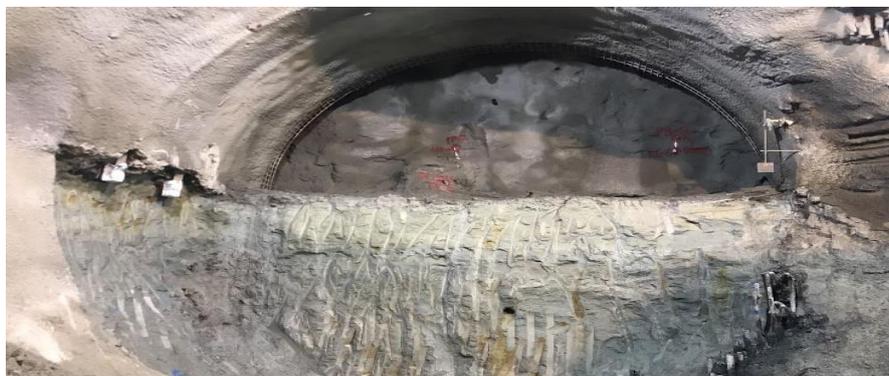
Figure 39. Old Alluvium Condition

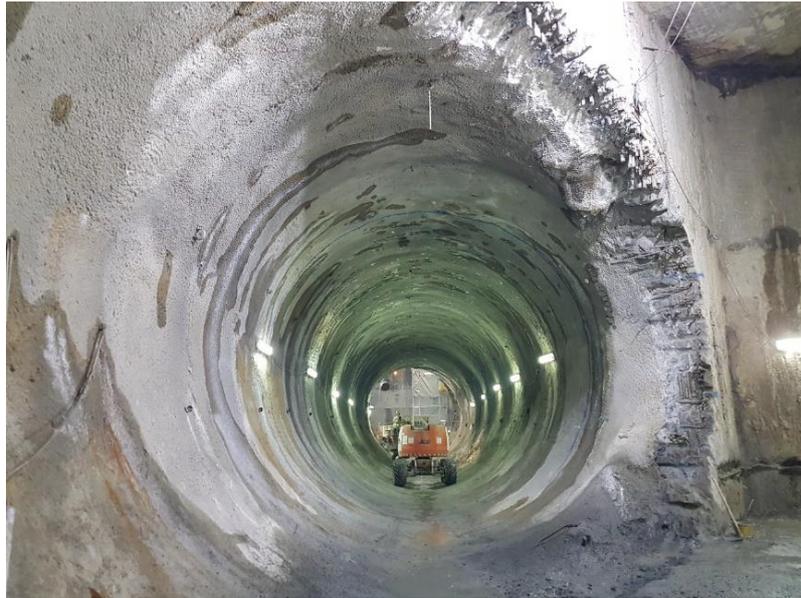
Figure 40. Completion of Lower Bound Excavation
