UNDERCROSSING LIVE TUNNELS IN PARALLEL BELOW THE WATER TABLE IN AN URBAN ENVIRONMENT

Diwakar Velu¹, Amsyar Tamami², Ramesh Nair³

ABSTRACT: Singapore Metro system has been developing in recent years to enhance the connectivity of existing network Mass Rapid Transit (MRT) system. Currently, there are 5 lines across the island in operation – North South Line (NSL), East West Line (EWL), Circle Line (CCL), North East Line (NEL) and Downtown Line (DTL). In addition, Thomson-East Coast Line (TEL) is under construction and 2 more lines – Jurong Region Line (JRL) and Cross Island Line (CRL) – are under planning. This increased connectivity has resulted in a more complex train network, which in turn poses greater construction risk of tunneling under or above existing lines. Contract T222 involves the construction of Outram Station and the TEL tunnels. The Outram Station will become an interchange connecting 2 existing lines in the Central Business District (CBD) located between Havelock Station (HVL) and Maxwell Station (MAX), overcrossing the existing NEL and undercrossing the EWL tunnels. One unique aspect of T222 is that the tunneling works undercrossing the EWL tunnels are in parallel

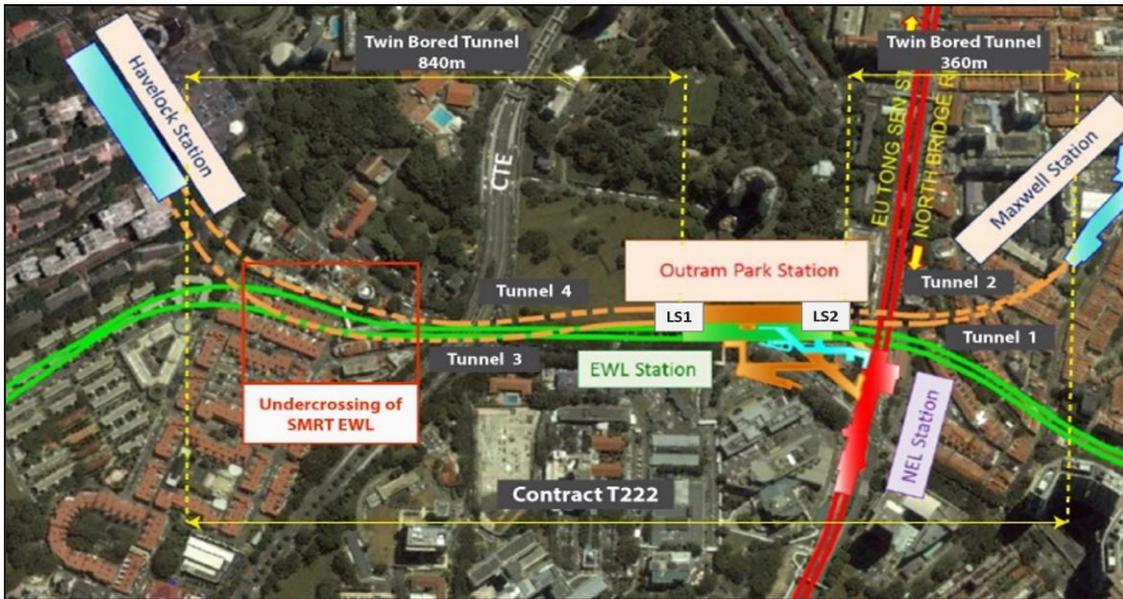
With reference to Figure 1, there are 2 launching shafts (LS1 & LS2) located within Outram Park Station. Starting from LS2, the 360m-long twin bored tunnels 1 and 2 towards Maxwell station were constructed using two Earth Pressure Balance Tunnel Boring Machines (EPB TBM). Subsequently, the TBMs were reassembled at LS1 to complete the 840m-long twin bored tunnels 3 and 4 towards Havelock station. For LS1, there was undercrossing of several

Figure 1. Tunnel drives from Outram Park Station to Havelock Station and Maxwell Station

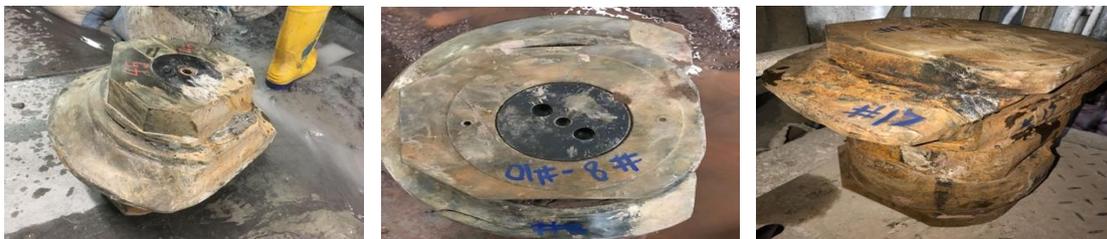
One other key observation from the tunnel drive was the tool wear trend. TBM 3 has 13 CHIs whereas TBM 4 has 8 CHIs during the undercrossing of the EWL Tunnels. The reason being a conservative approach followed for the first tunnel drive. Quick Intervention resulted in changing less % tools. This resulted in overloading of disc cutters while mining in sandstone and thus having more stoppages.

Figure 11. Worn-out disc cutters TBM 3

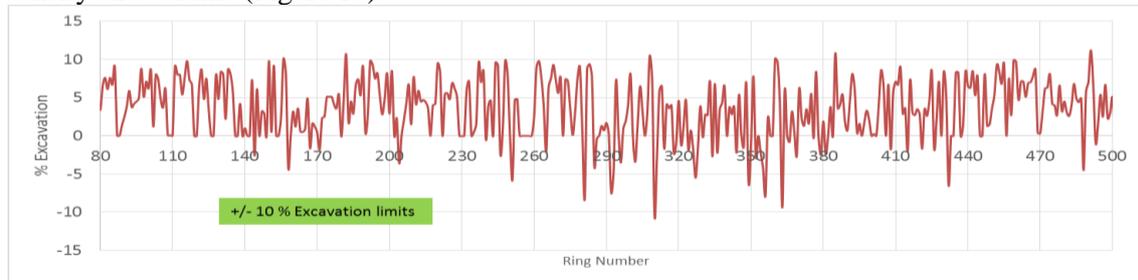
Due to the shallow cover of the EWL at the initial section the face pressure was maintained slightly higher than the target/design face pressure. In addition any over/under excavation was maintained within 10% limit and anything beyond this limit was carefully assessed in terms of density and volume (Figure 15).

Figure 15. Graph of Percentage (%) Excavation against Ring Number for TBM 4
